## Structural Degradation of Oil Tanker Operating in Indonesian Waterways

S Komariyah<sup>1</sup>, F A Prasetyo<sup>1</sup>, V N Garjati<sup>2</sup>, M R F Hariadi<sup>1</sup> and A R Prakasa<sup>1</sup>

<sup>1</sup>Research & Development Division, Biro Klasifikasi Indonesia, Yos Sudarso 38-40, Tg. Priok Jakarta, Indonesia

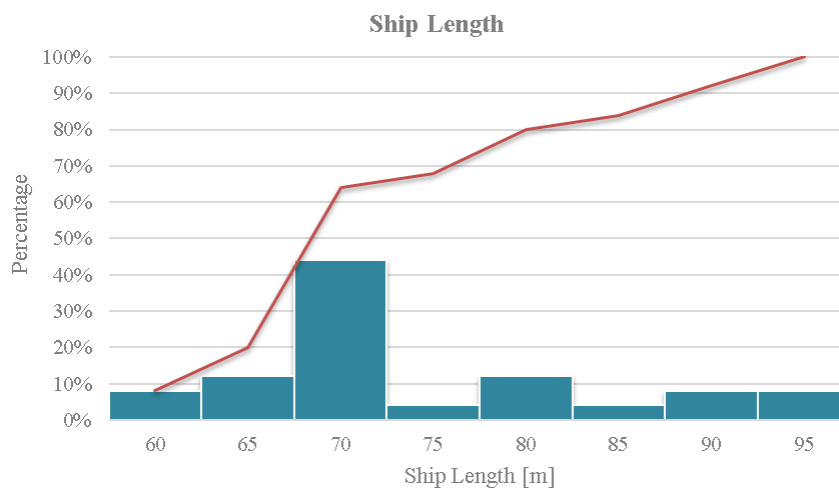
The age of selected ships is figured in Figure 2. The age of selected ships varies from 5 years to 23 years. The distribution of ship's age shows that the major contribution is 20.83% with 22 years old. Figures 3 and 4 show the distribution of ship length and ship size in GT. The selected ships have major distribution of length between 65 meter to 70 meter and is also majorly distributed between 1400 GT to 1500 GT in ship size.

**Figure 3.** Length distribution of oil tanker ships

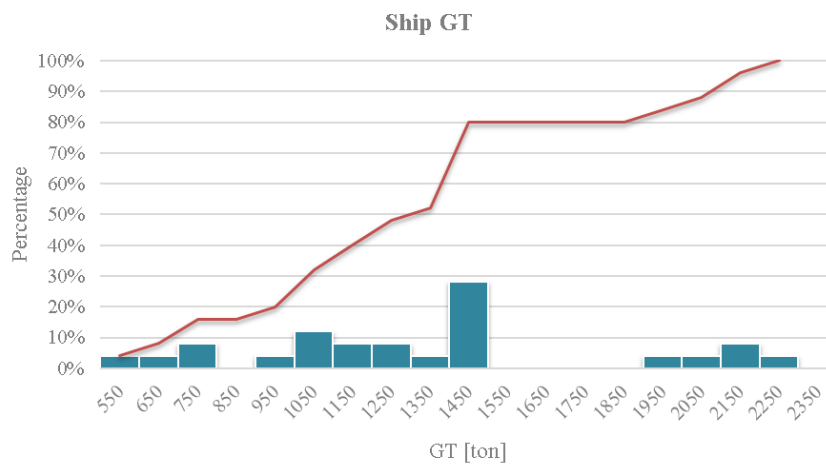
**Figure 4.** GT distribution of oil tanker ships

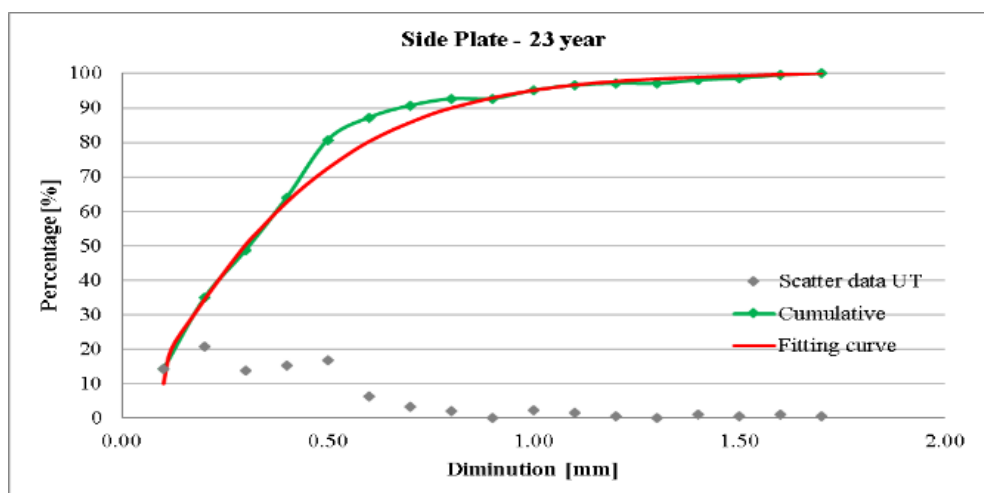
**Figure 5.** Probability density at structural member at various ship's age. Side plate is shown.

Figure 5 and Figure 6 show the example of probability density for side plating, and inner bottom plating of Oil Tankers at a stipulated ship age. The grey point is the scatter data of UT Reports while the green line is the graph for each cumulative probability. The red line is plotting the results of a proposed probabilistic model. It is shown that the fitness of the proposed probabilistic model and that of cumulative probability density are still acceptable. The other probability density of deck plating and bottom plating area are also determined.

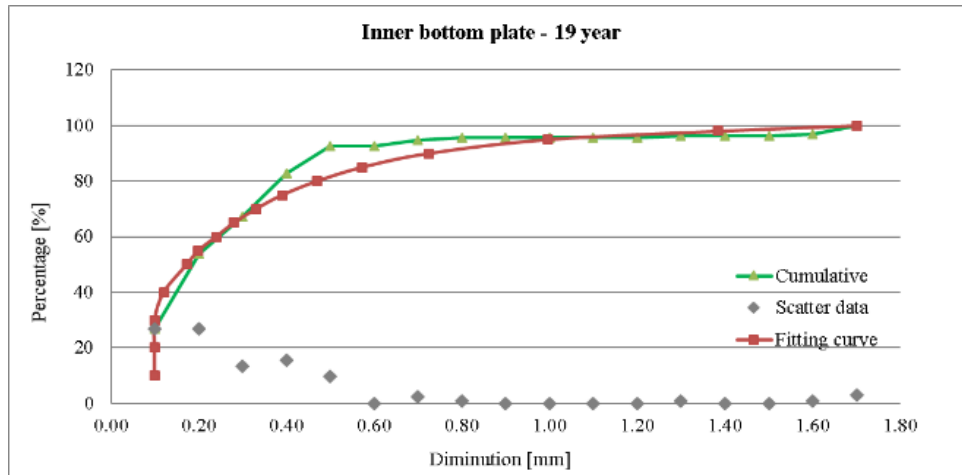
Figure 6. Probability density at structural member at various ship’s age. Inner bottom plate is shown.

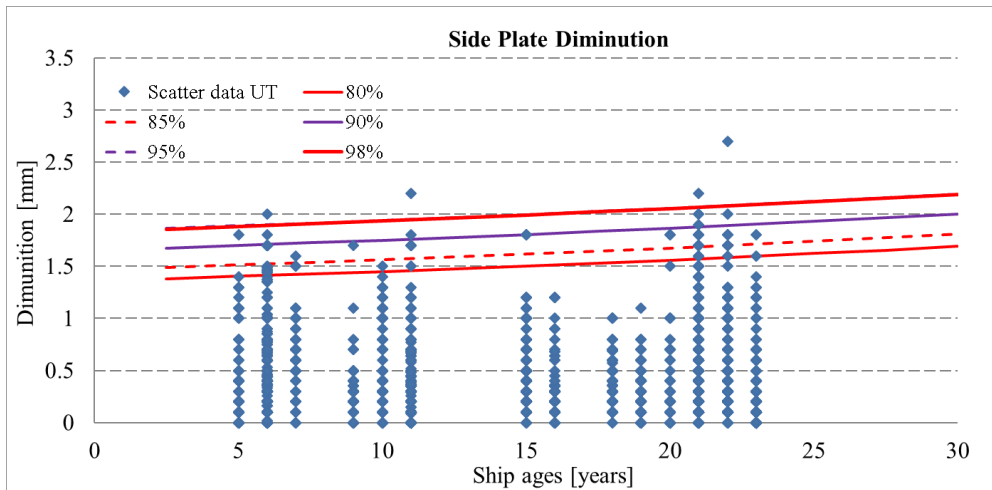
The amount of corrosion margin is varying depending on cumulative probability. 5(five) values of cumulative probability levels are chosen in this works. There are 80%, 85%, 90%, 95% and 98%. Figure 7 displays the cumulative probability values of 80%, 85%, 90%, 95% and 98% on the deck plating. Figures 8-10 are for the side plating, bottom plating and inner bottom plating. The scatter of data UT are also plotted in those figure based on the ship ages. The selected cumulative probability is a value where the average and the maximum diminution are not greater than the value for both the entire population and for each age of Oil Tankers.

**Figure 8.** Probability cumulative for side plate

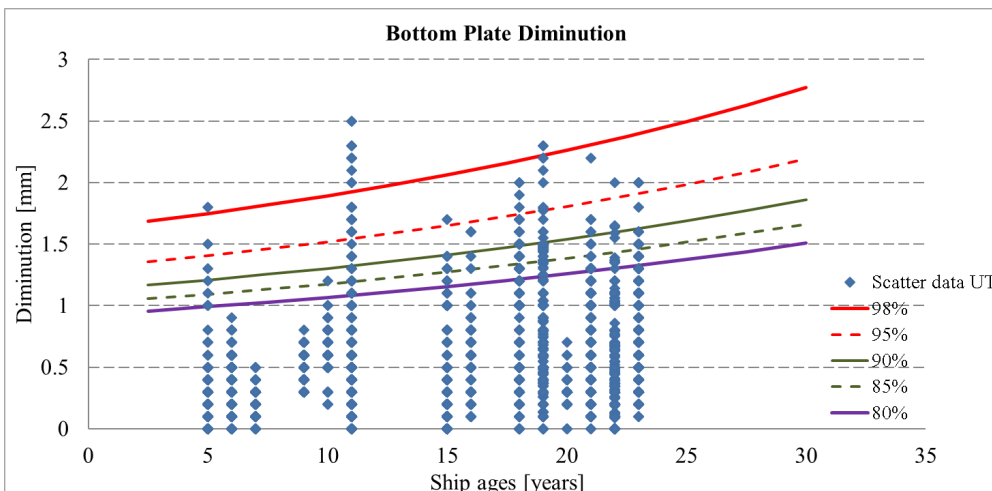
**Figure 9.** Probability cumulative for bottom plate

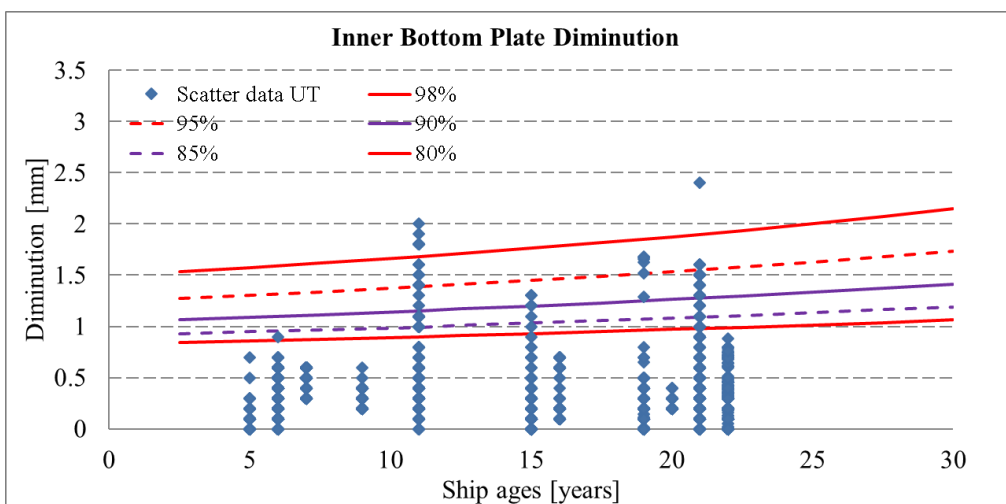
**Figure 10.** Probability cumulative for inner bottom plate
